Manufacturer Boosts Productivity and Workflows with Barcode Inspection Printer

T8000 0DV-2D Achieves Zero Relabeling, Saves Up To 5 Labor Hours Per Day

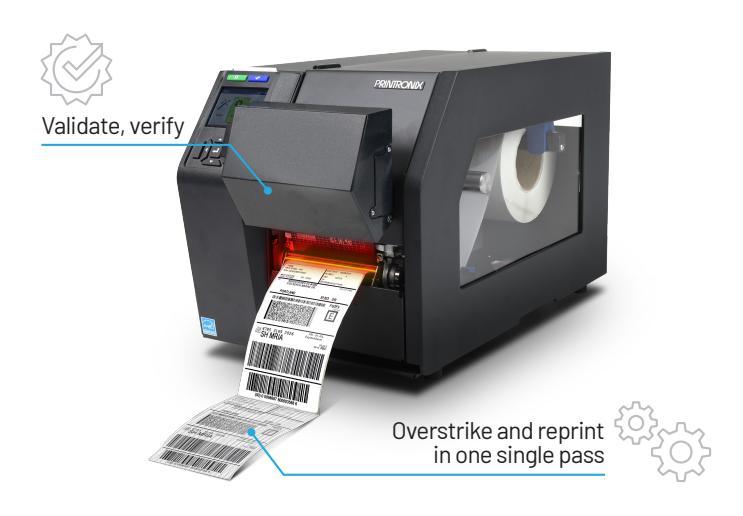
Figure 1: The T8000 ODV-2D printer does not require any operator intervention. It enables you to print, validate, verify, overstrike and reprint labels in a single pass.

The robust T8000 ODV-2D barcode inspection printer includes a built-in barcode verifier that grades and validates barcodes to ISO standards. The fully automated T8000 ODV-2D can also overstrike bad labels and reprint a new one without operator intervention.

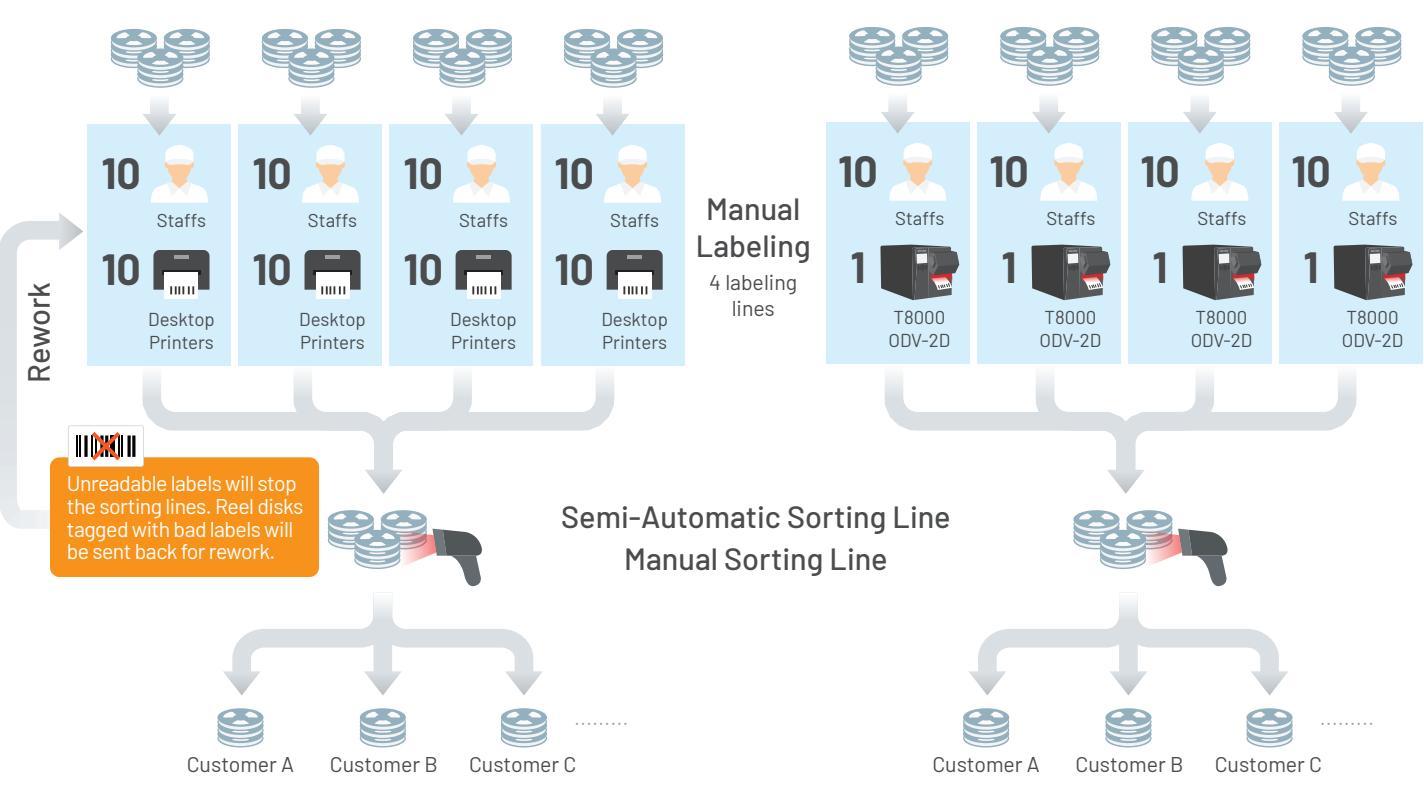
Figure 2: Before and After the T8000 ODV-2D Deployment

- **10** desktop printers per labeling line due to low print speed.
- Maintained **40** printers.
- 1% of labels are bad, around 640 labels are reworked per day.
- 5 hours wasted per day with 21% of productivity lost.

- **1** T8000 ODV-2D inspection printer per labeling line due to fast 8 ips print speed.
- Only need to maintain **4** printers, a significant reduction!
- Zero bad labels for rework.
- Zero hours and labor wasted.

Reel disks tagged with part number labels are sent to labeling lines.
